MERRIMACK RIVER BASIN
SALEM, NEW HAMPSHIRE

MILLVILLE RESERVOIR DAM

N H 00030
NHWRB 209.08

PHASE I INSPECTION REPORT
NATIONAL DAM INSPECTION PROGRAM

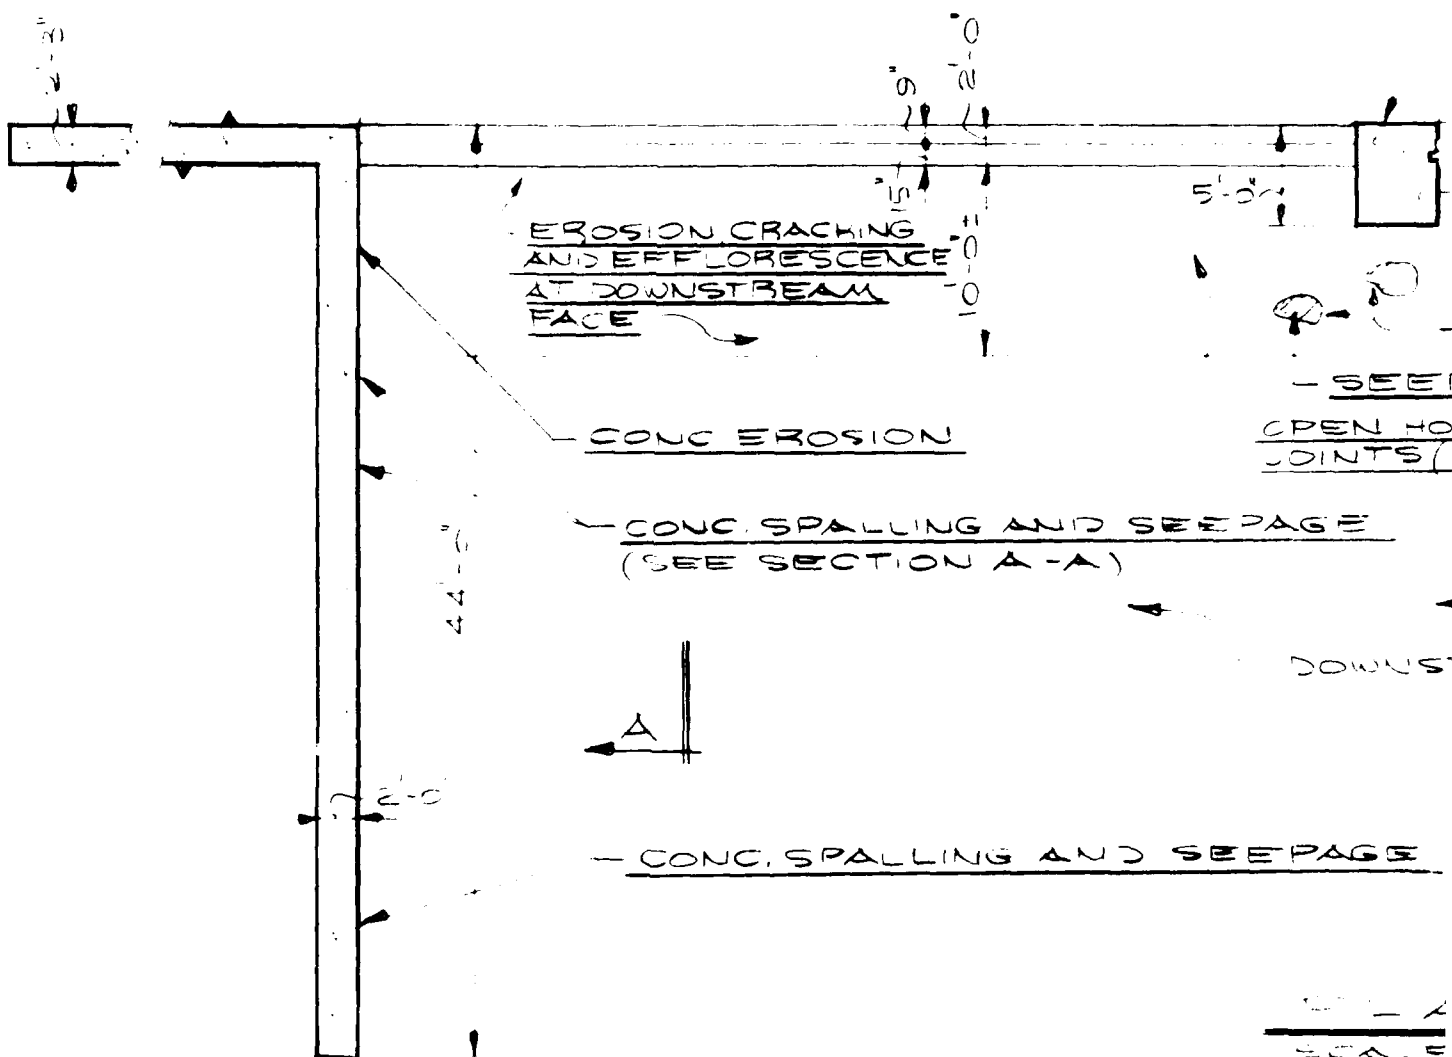
CONC. EROSION AT THE
UPSTREAM FACE OF PIEN
